Report of Failure Mode

Date of Failure Incident: February 29, 2024

Failure Event Description: Failure of ingress TCP/IP to datacenter; east-west traffic unaffected; outbound email unaffected

Primary Event: Planned upgrade event on network providers equipment (NPE)

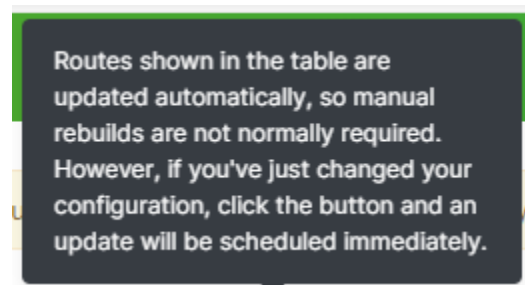
Within the Firewall settings of the Meraki Security Appliance is a route table report showing route data saved in the internal database; however, these routes may become unusable, corrupt or unapplied after an upgrade. The solution after an upgrade is to rebuild route tables to be certain they are functional. It is presumed that Meraki is aware route tables may require a rebuild or the feature would be unnecessary.

Rebuilding routes after each firmware upgrade should be added to maintenance protocols to ensure resolution of any future routing issues including VPN. This “pop-up” that appears on the information icon tells the story: “*manual rebuilds are not normally required. However, if you’ve just changed [or had changed through firmware] your configuration . . .*”
